Manhole Inspection Summary

Manhole # S47M__003MH

Insp Date: **9/3/08 9:21 AM**

Location Address: **2351 boston st**

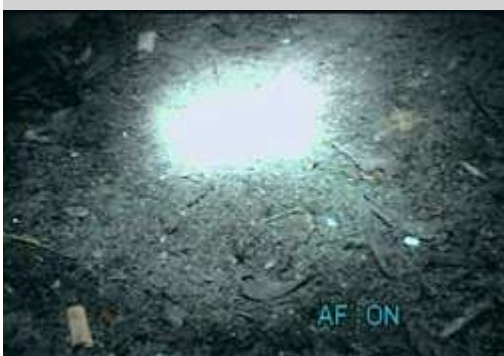
Defect 3

Condition: ☐ Sound ☐ Cracked ☐ Root Intrusion ☐ Deteriorated ☐ Leaks ☒ **Debris**

channel debris

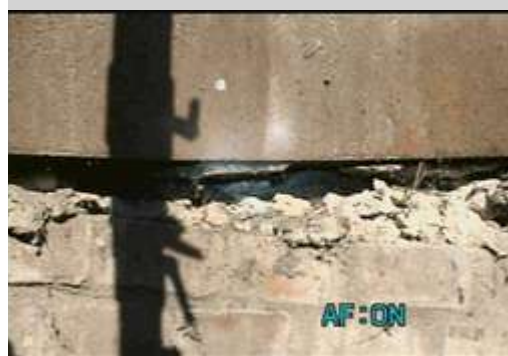
Defect 2

Condition: ☐ Sound ☐ Cracked ☐ Root Intrusion ☐ Loose Brick ☒ **Deteriorated**

Chimney deteriorated, frame adj

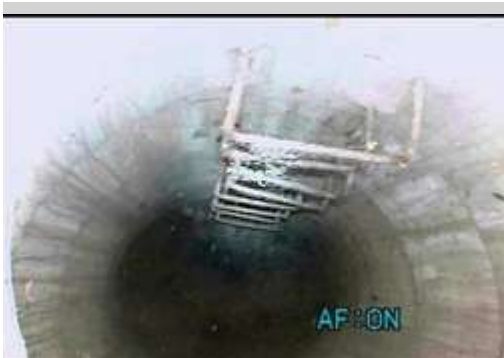
Defect 1

Count: **9** Missing: **0** ☒ **Corroded**

steps

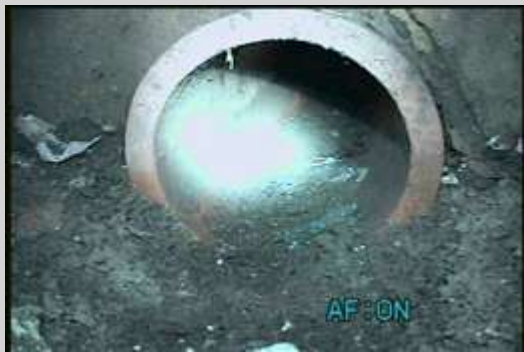
12 O'Clock Outflow

8 in. Circular Gravity Sewer
Pipe Out @ 12 O'Clock
